Land Subsidence Rate in the Maricopa-Stanfield Sub-Basin, Pinal County
Based on Radarsat-2 Satellite Interferometric Synthetic Aperture Radar (InSAR) Data
Time Period of Analysis: 1.0 Years 03/19/2015 To 03/13/2016

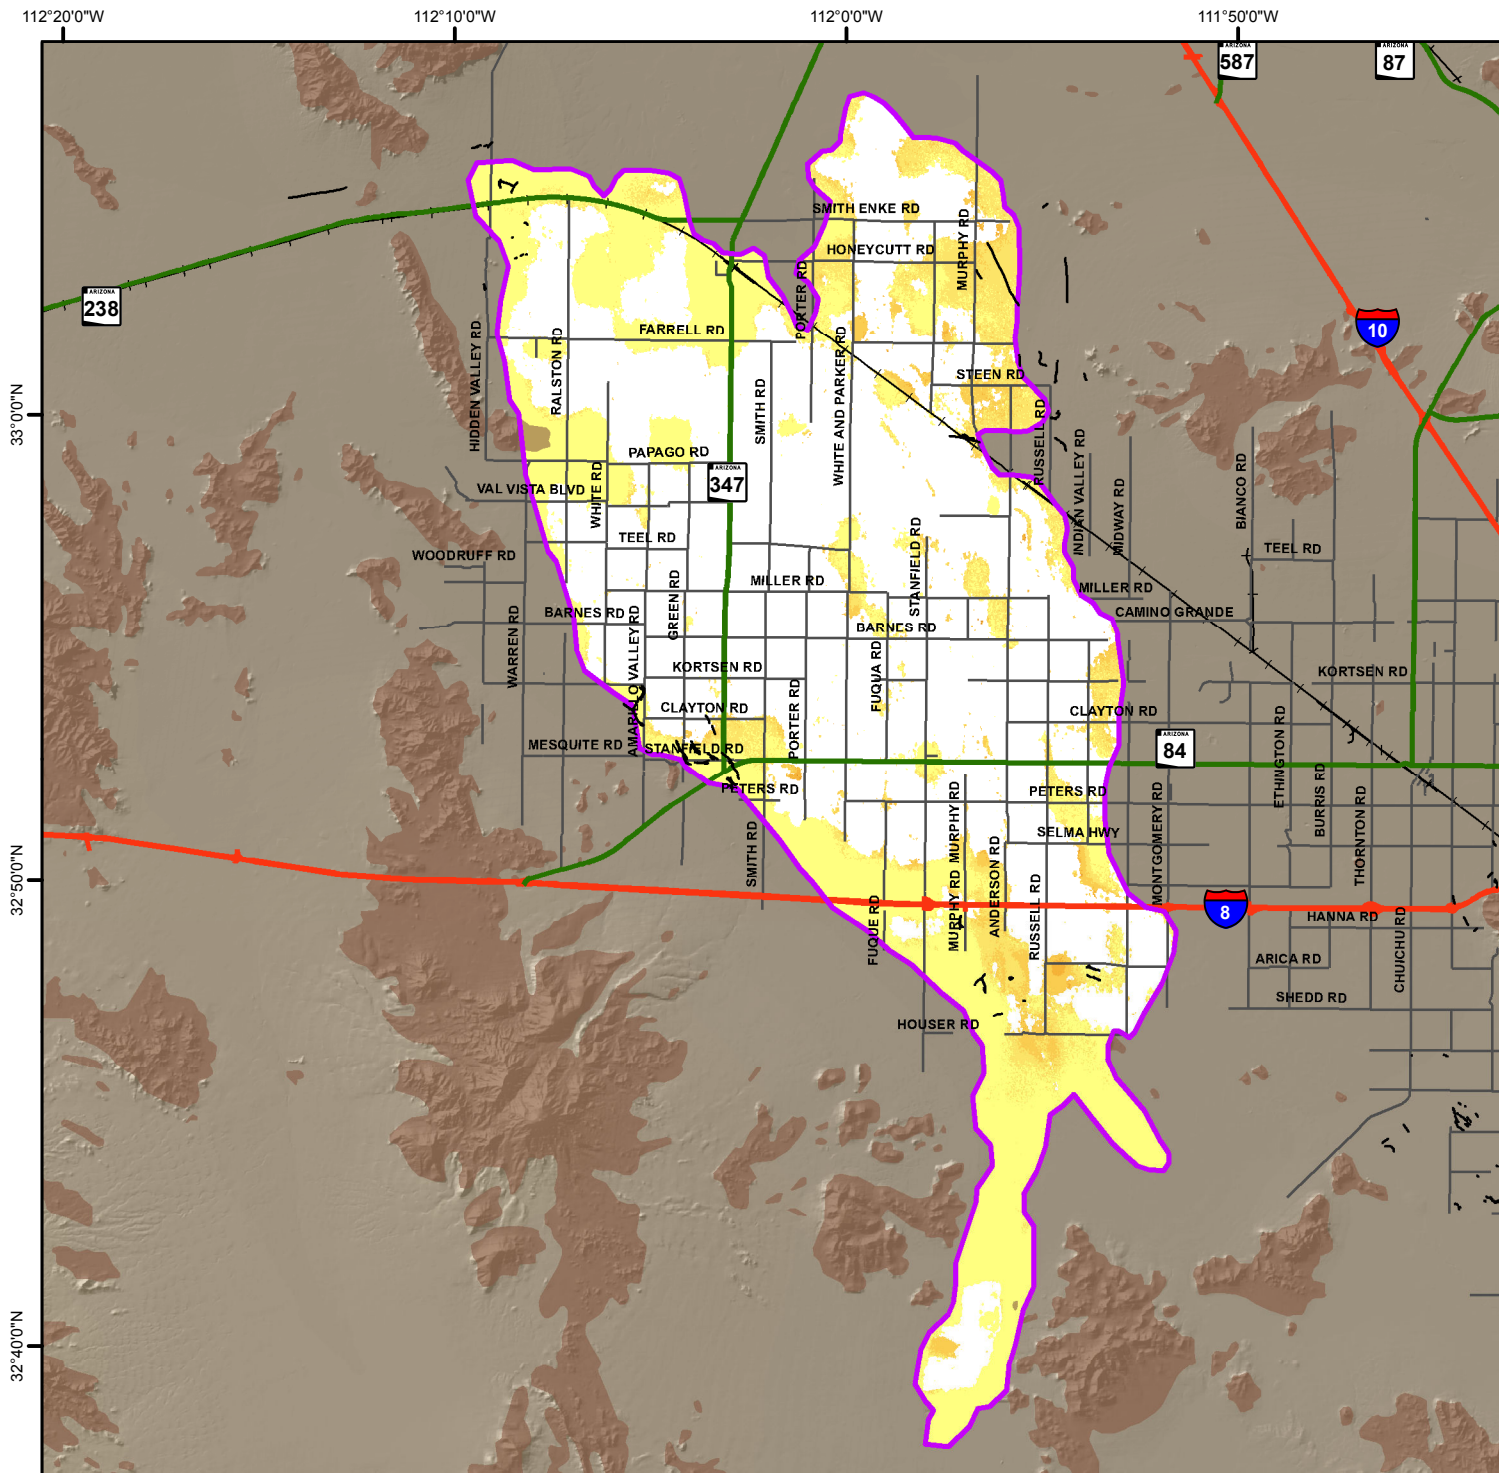
Decorrelation (white areas) are areas where the phase of the received satellite signal changed between satellite passes, causing the data to be unusable. This occurs in areas where the land surface has been disturbed (i.e. bodies of water, snow, agriculture areas, areas of development, etc).

Earth fissures were mapped by the Arizona Geological Survey. For information on earth fissures visit: www.azgs.gov/EFC
